# **RPSEA**

## ***Phase II Final Technical Report***

***Autonomous Inspection of Subsea Facilities***  
**09121-3300-05**

**March 27, 2012**

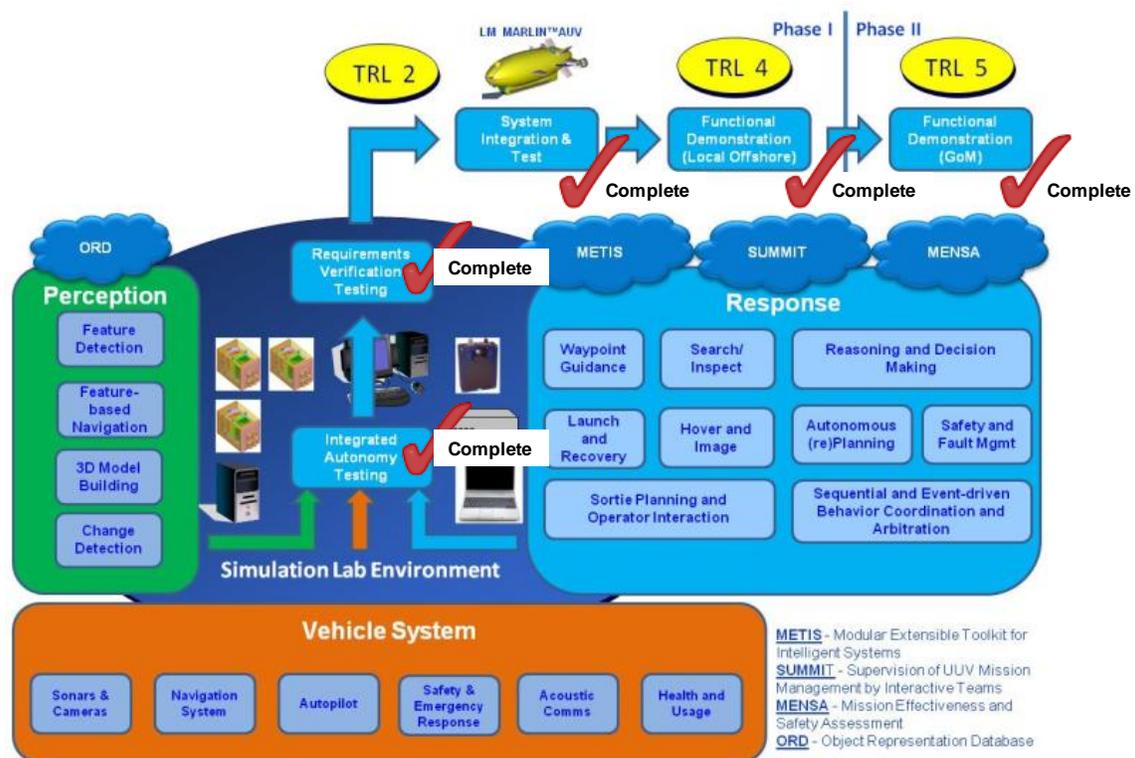
**Figure 1 - Autonomy Technology Development - TRL Progression**

In figure 1, the green, orange, and cyan colored boxes indicate the separate pieces of autonomy technology that were developed, integrated, and tested as part of the RPSEA 09121-3300-05 Phase I and II contract. The smaller boxes within each of these represent the required capabilities within each piece of autonomy. Once the individual technologies were developed, they were integrated and tested within Lockheed Martin’s simulation laboratory environment as indicated by the arrows from each piece of autonomy, achieving TRL 2. After successfully verifying the autonomy software requirements in the simulation lab, the autonomy software and the Marlin™ AUV hardware were integrated in the shoreside and local offshore environments achieving

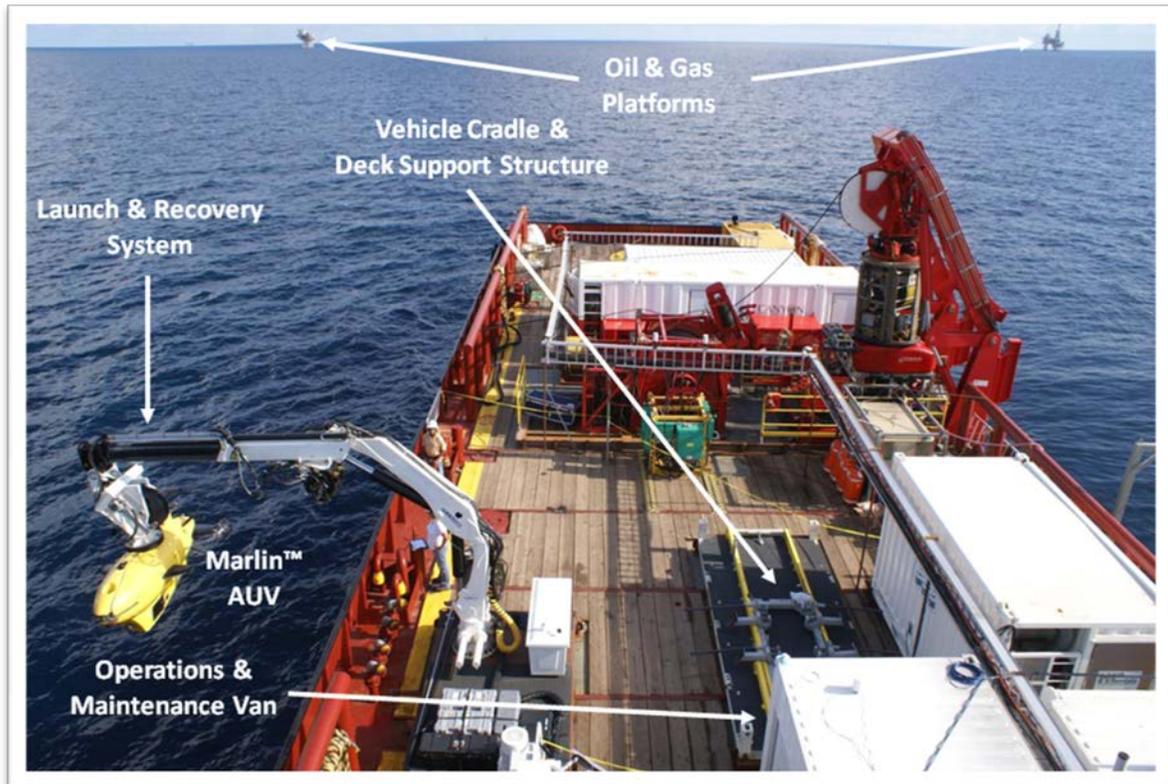
**Figure 3 - Lockheed Martin Marlin™ AUV Inspection System onboard Abdon Callais's M/V Jessica Moore**

Mobilization of Lockheed Martin's Marlin™ AUV inspection system onboard Abdon Callais's M/V Jessica Moore commenced on July 6, 2011 and the system was ready for offshore operations following a pier side system level checkout on July 8, 2011. The complete Marlin™ AUV system as mobilized onboard the M/V Jessica Moore is shown in Figure 3.

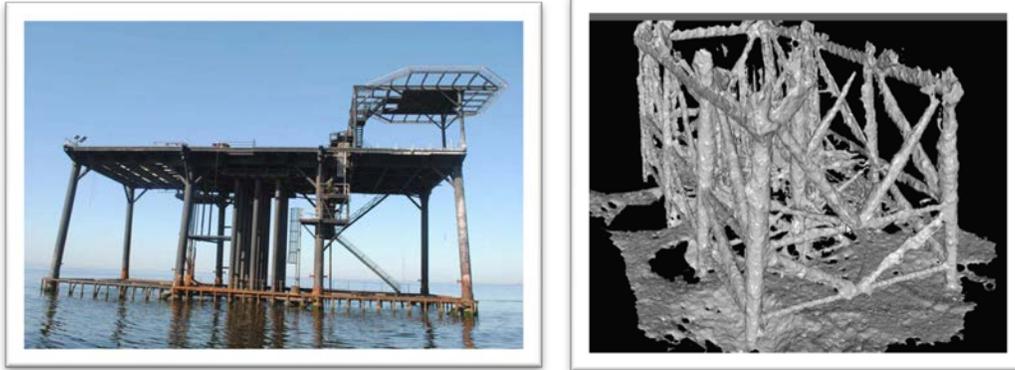
**Figure 4 –Chevron Platform #1 with High Resolution 3D Model Generated from Marlin™ AUV Model Building Mission**

Over the next four days (July 9 - 12), the Lockheed Martin operations team conducted launch and recovery operations to validate the procedures and provide the team with additional on-the-job training/rehearsal with launching and recovering the Marlin™ AUV from a ship for the first time in the GoM environment. On July 15, following the two-day mobilization and checkout of Chevron specific equipment, the Lockheed Martin team launched the Marlin™ AUV and performed the first autonomous scan (completed in only 27 minutes) of a fixed platform (Chevron Platform #1) from which a high-resolution 3D model was then constructed as shown below in Figure 4.

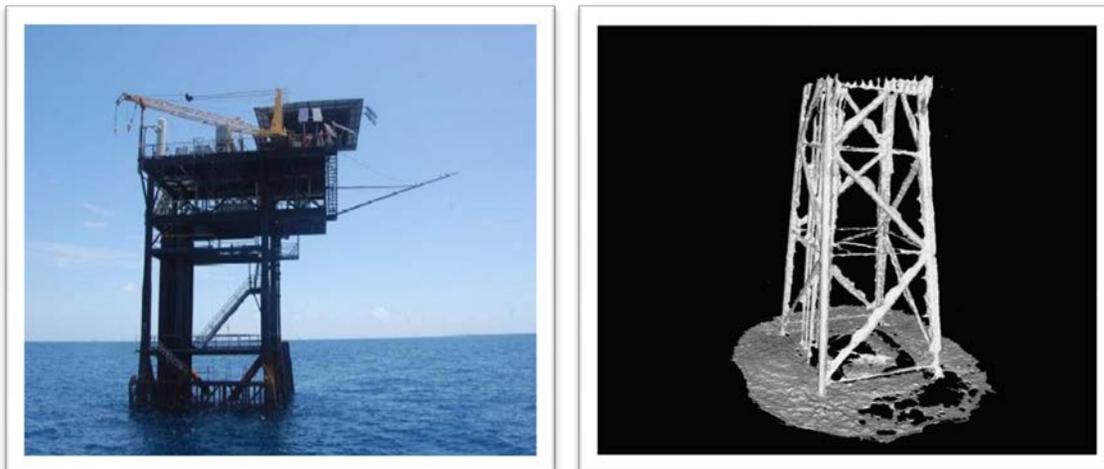
**Figure 5 – Chevron Platform #2 with High Resolution 3D Model Generated from Marlin™ AUV Model Building Mission**

The operations then moved to a second fixed platform (Chevron Platform #2) and completed similar model-building missions. The results of the scanning runs on Platform #2 are shown in Figure 5.

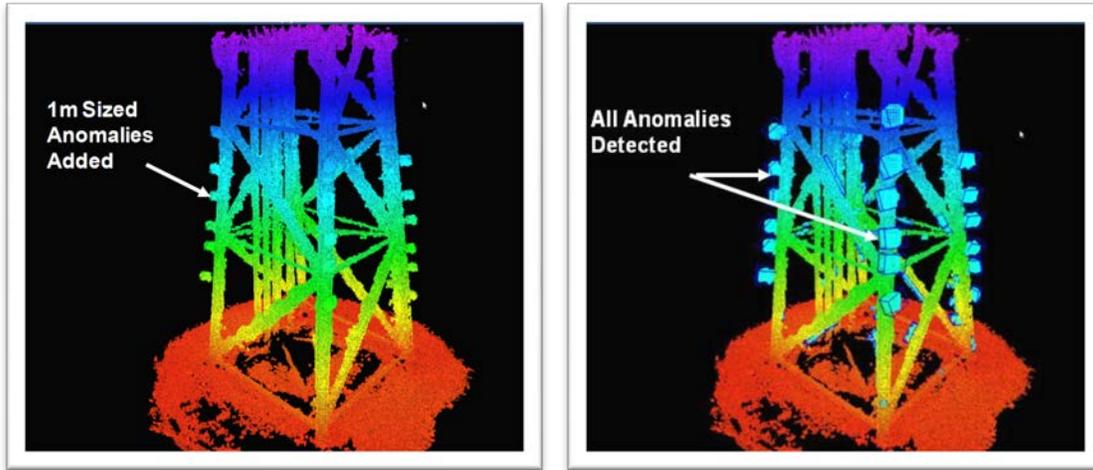
detected. Figure 6 shows the results of this inspection run. The left side of the figure shows the base model (one-meter sized anomalies added) and the right side of the figure shows the anomalies that were detected (identified by a blue box) by the Marlin™ AUV during the inspection mission.

**Figure 6 - Marlin™ AUV Platform Inspection Mission Results of Chevron Platform #2 with Anomalies Detected and Highlighted**

After completing a series of model-building missions at various offset distances around Chevron Platforms #1 and #2, autonomous inspection missions were conducted to demonstrate the system’s ability to detect large scale anomalies. A large-scale anomaly is defined as a minimum of one cubic meter- sized anomaly in free space (openings within platform jacket) or in encumbered (against structural members or joints) space or a one cubic-foot sized anomaly in free space. Once the 3D model of the platform was constructed from the model building runs (Figures 4 and 5), several anomalies were incorporated into the 3D models of the platforms which became the base (*a-priori*) model for further inspection missions. Autonomous inspection missions were then run around platform #2 at 15-meter offset comparing the images collected during the mission to the base (altered with anomalies) 3D model, identifying changes in real-time. The Marlin™ AUV inspection run resulted in 100 percent of the anomalies being

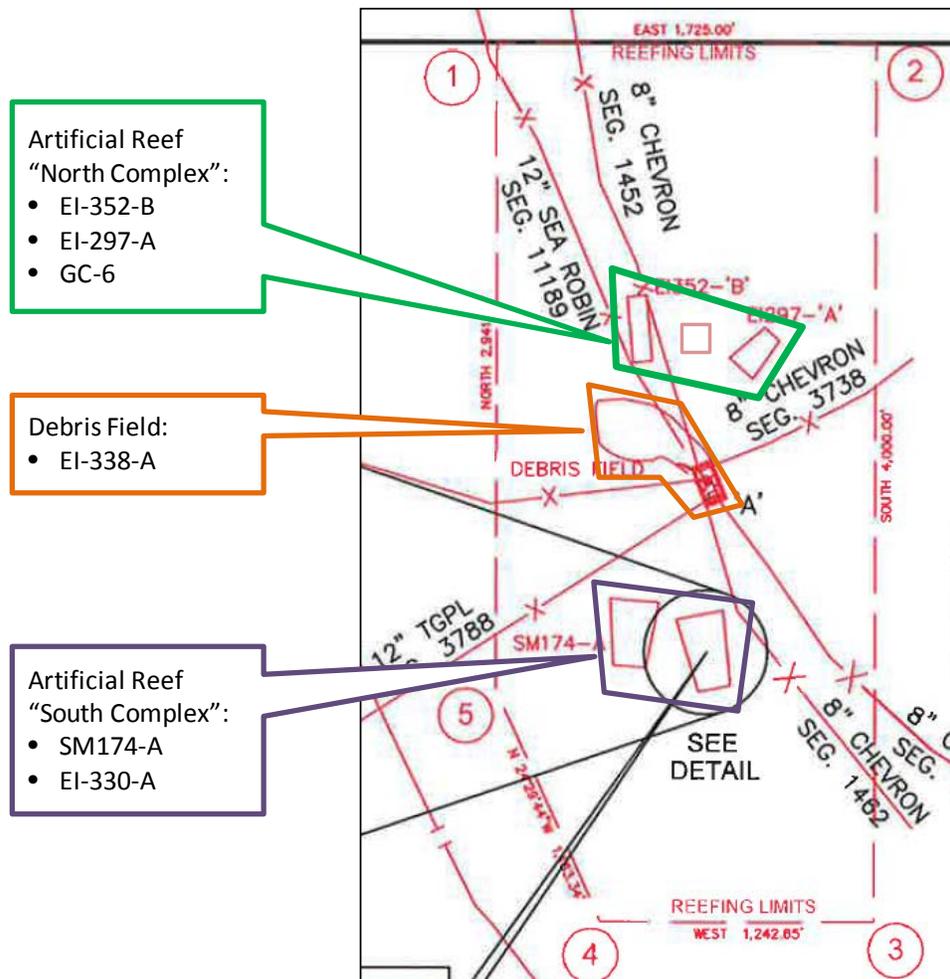
**Figure 7- Artificial Reef Site EI-338**

The Part 1 operations were successfully completed on July 20, 2011, and the Lockheed Martin team disembarked while Chevron performed other activities over the next 11 days. The Lockheed Martin team re-embarked on August 1, 2011, and started conducting survey missions of an artificial reef site EI-338. This site consisted of five reefer platforms located on the seafloor with a debris field in between. This artificial reef site is shown in Figure 7.

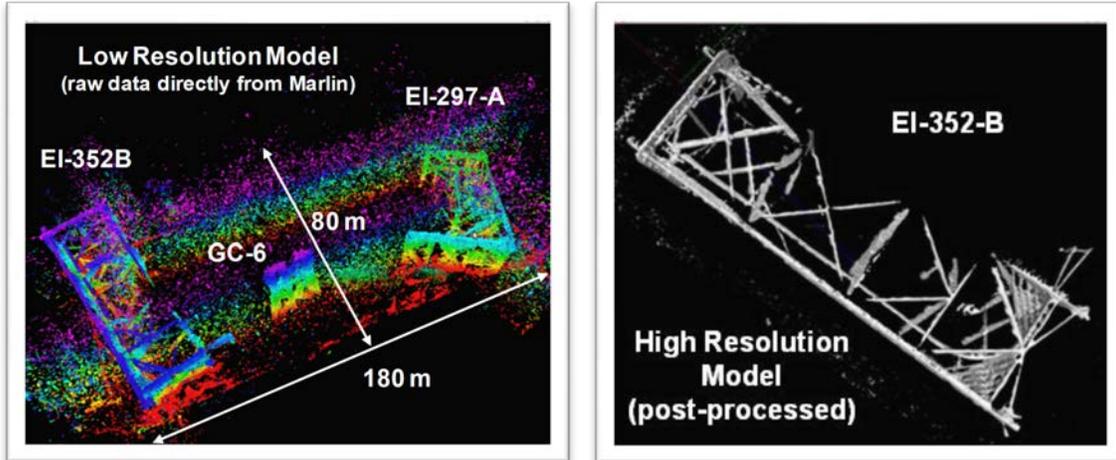
**Figure 8 - 3D Models Constructed of Artificial Reef Site EI-338 (North Complex)**

Over the next seven days, the Lockheed Martin Marlin™ AUV conducted autonomous survey (imaging) missions within the EI 338 reef complex. Since this operation was not part of the original scope of the demonstration, the Lockheed Martin operations team had to generate new operational concepts for conducting this type of survey in a field that had no surface-piercing features that could be used as a reference. The new operational concept was quickly developed and validated in the onboard simulation environment prior to the actual execution of the mission, demonstrating the flexibility of the Marlin™ AUV inspection system. The survey was conducted by starting at a depth (first 100 feet) where no structure was expected to be present, and operated in a spiral path, collecting 3D sonar data and constructing 3D models similar to the way it was accomplished in Part 1 for fixed platforms. After low-resolution models were generated the condition of the reef site became clearer, the Marlin™ AUV was sent deeper and closer to obtain higher resolution sonar data for building more accurate 3D models of the reefed platforms. The results of the spiral survey missions and subsequent construction of a high resolution 3D model for the Artificial Reef’s North Complex is shown in Figure 9.

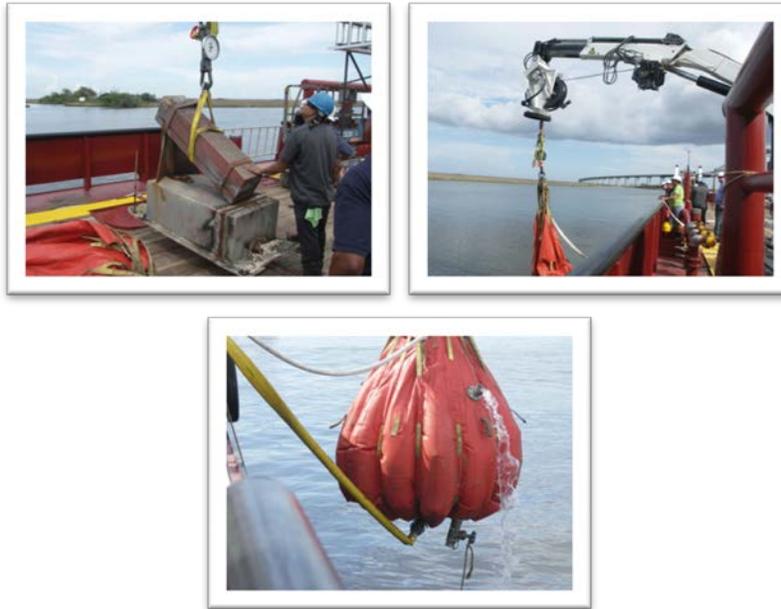
**Figure 10 - Load Test of Marlin™ Launch and Recovery Crane**

The Lockheed Martin team arrived at the Abdon Callais shipyard on July 5, 2011, and mobilization activities began. Over the next four days, the equipment was placed and secured to the deck and cabling was routed between the deck generator, operations and maintenance van and the Marlin™ AUV launch and recovery knuckleboom crane. The launch and recovery crane was also load tested during this period and was witnessed by an inspector from the American Bureau of Shipping. Load testing of the Marlin™ AUV launch and recovery knuckleboom crane is shown in Figure 10.

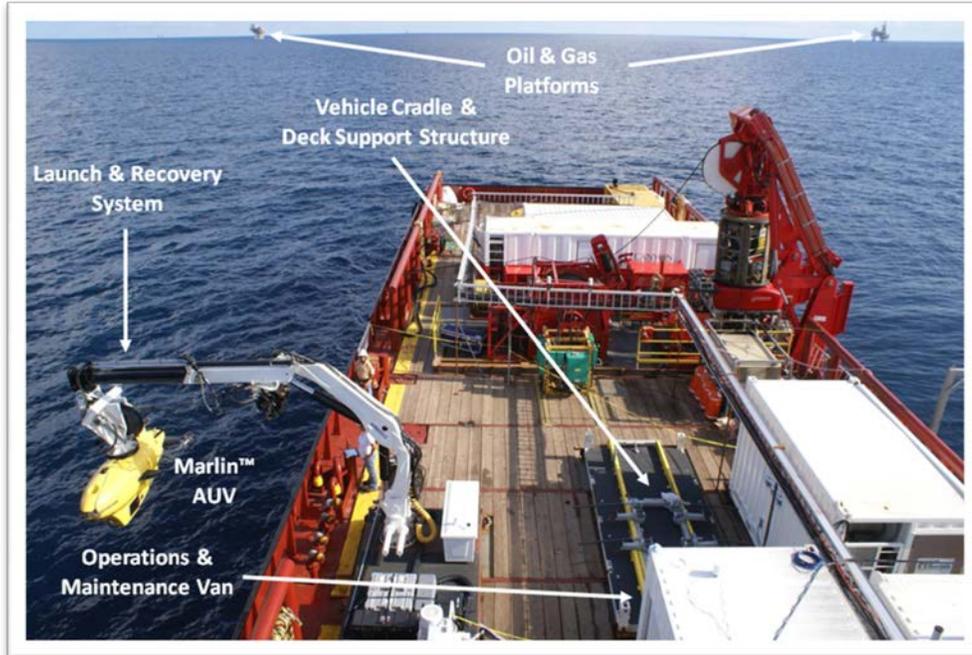
**Figure 11 - Lockheed Martin's Marlin™ AUV Underwater Facility Inspection System Mobilized onboard Abdon Callais M/V Jessica Moore**

The final pierside checkout of the Lockheed Martin Marlin™ AUV inspection system was completed on July 8, 2011, and the system was ready to begin operations on July 9, 2011. The system as configured onboard the M/V Jessica Moore is shown in Figure 11.

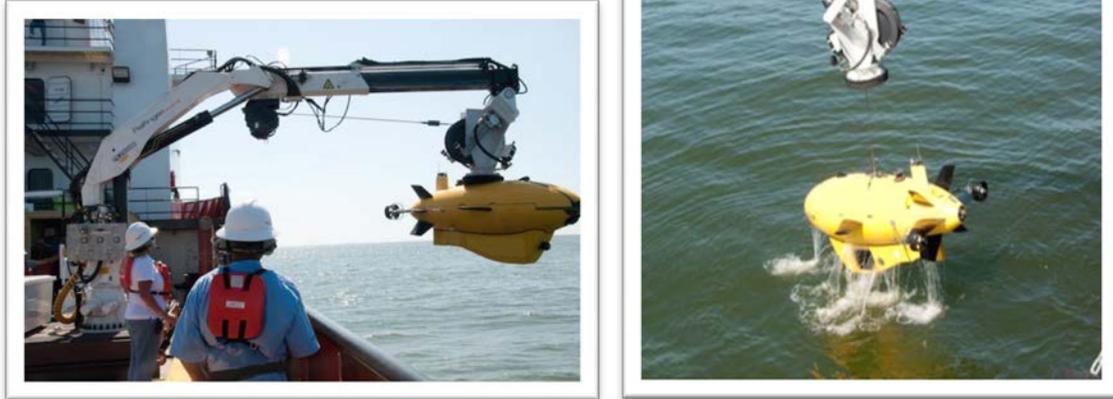
**Figure 12 – Marlin™ AUV Launch & Recovery**

On July 9, 2012, the Jessica Moore departed the pier to conduct offshore launch and recovery operations approximately five nautical miles from shore in 60 feet of water. Over the next four days, the Lockheed Martin team performed launch and recovery operations from the vessel. The purpose of this exercise was to validate the procedures for launching and recovering the Marlin™ AUV from the starboard side of the M/V Jessica Moore and give the Lockheed Martin launch and recovery crew a chance to rehearse launching and recovering the Marlin™ AUV in the actual Gulf of Mexico environment. This also provided an opportunity to train additional crane operators. During the first two days of this period, the Marlin™ AUV was launched and recovered several times without releasing the vehicle from the crane's lift line. The launch and recovery procedures were streamlined as a result of these operations, making the launch and recovery sequence more efficient. At the end of this period, the time for overboarding and recovering the AUV back to the cradle was less than 15 minutes. Figure 12 shows the Marlin™ vehicle being launched and recovered from the M/V Jessica Moore.

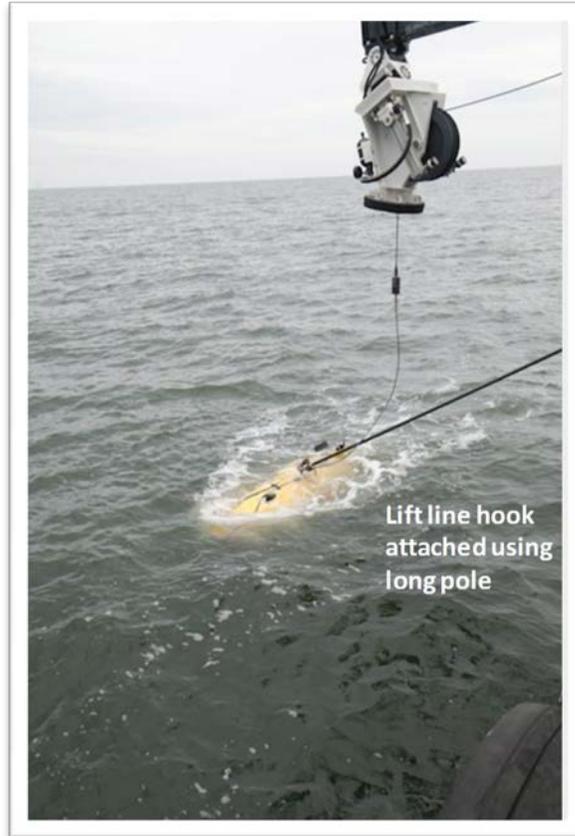
**Figure 13 – Manual Capture of Marlin™ AUV**

In the event that the vehicle is not able to autonomously home in and capture the lift line, the vehicle will be surfaced and the crane's recovery hook manually attached (using a long pole from deck of the vessel) to the lifting clevis located on top of the vehicle. Once the lift line hook is attached, the vehicle is recovered in the same manner as for a normal recovery.

Figure 13 shows a manual capture of the vehicle underway.

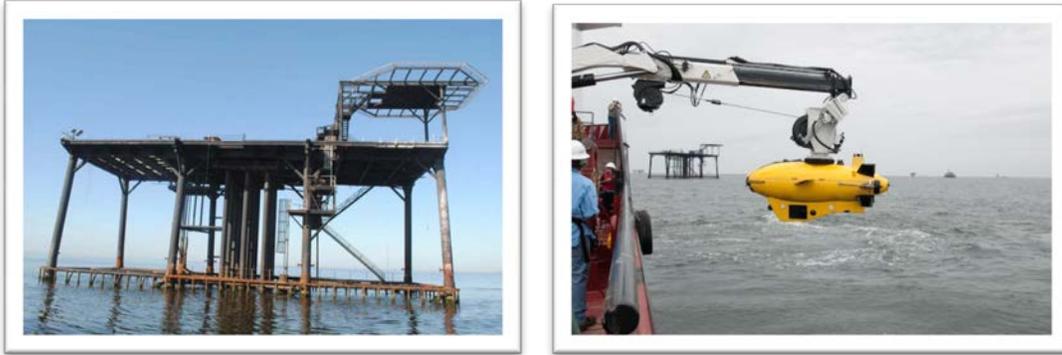
**Figure 14 – Arrival at Chevron Platform #1 (8 pile platform in 55 feet of water)**

The M/V Jessica Moore arrived at the first fixed oil and gas platform to be inspected by the Lockheed Martin AUV system. This platform was a Chevron-owned asset (#1), which was an eight- pile platform located in approximately 55 feet of water. This platform is shown in Figure 14.

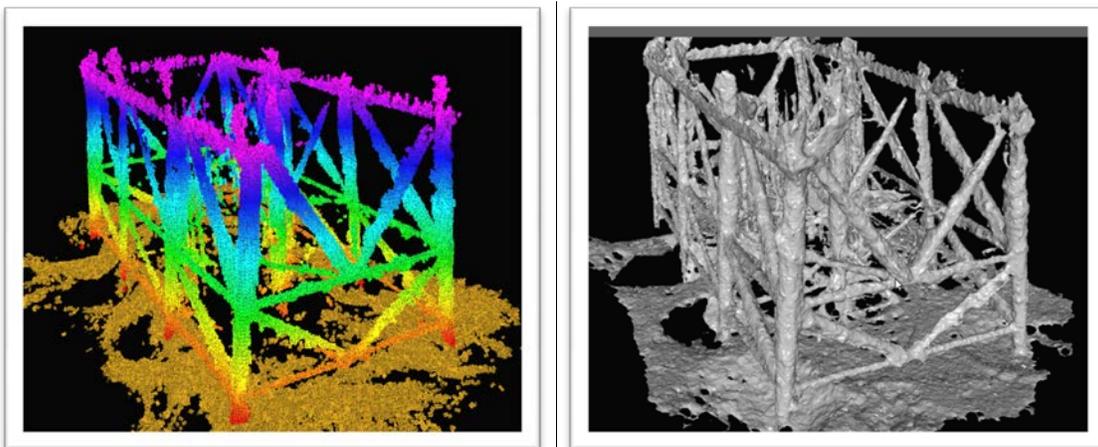
**Figure 15 – Results from Model Building Mission for Platform #1 at 15m Offset**

The first autonomous mission that was conducted on Chevron Platform #1 was a model-building mission, since no previous information (drawings or 3D models) about the platform existed. During this mission, the Marlin™ AUV autonomously circled the platform on a pre-planned mission at various standoff distances from the platform ranging from 50 meters to as close as 15 meters and at various depth slices in order to scan the entire height of the platform. The collected imagery of the platform using the Marlin™ onboard CodaOctopus Echoscope sonar was then used to construct a high-resolution 3D model of the platform via post processing of the data using a Lockheed Martin developed analysis tool. The resulting high-resolution 3D models from these scans, generated in one to two hours, are shown in Figure 15. The left side of the figure shows a high-resolution version of the constructed model that is colored by depth. The right side of the figure shows the same model after additional post processing which adds a skin to the structural members. Both models were created from sonar imagery data that was collected during the 15-meter offset runs.

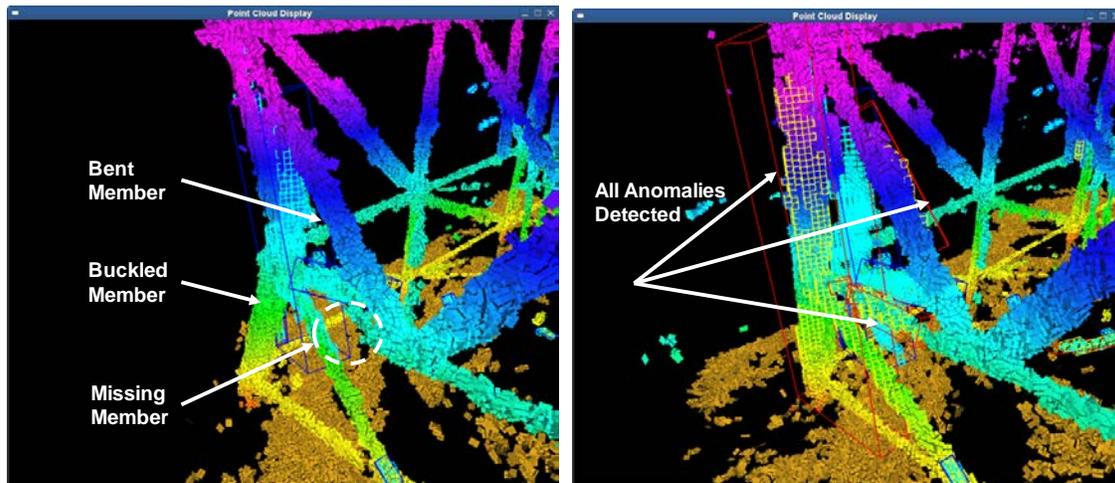
**Figure 16 – Results from Platform Inspection Mission for Platform #1 with Anomalies Detected**

building runs completed previously. Working closely with Chevron, various anomalies were incorporated into the 3D model and were representative of damage that might be expected to occur to a platform, including a bent member, a missing member and a buckled member. This altered 3D model then became the base (*a-priori*) model that was used as the basis for comparison during subsequent inspection runs. The altered 3D model was loaded into the Marlin™ AUV, and an inspection mission was conducted at 15-meter offset from the platform at increasing depth slices until the entire platform was imaged. The scanned imagery was compared to the base model and changes were automatically detected, highlighted, and localized in real-time. Figure 16 shows the results of the autonomous inspection mission around Platform #1. The left side of the figure shows the base (*a-priori*) model that was altered with anomalies, and the right side of the figure shows the imagery from the follow-on inspection mission overlaid on the base model with the changes highlighted with red and blue boxes, depending on whether it was a positive change (something that should not be there that is) or a negative change (something that should be there that is not).

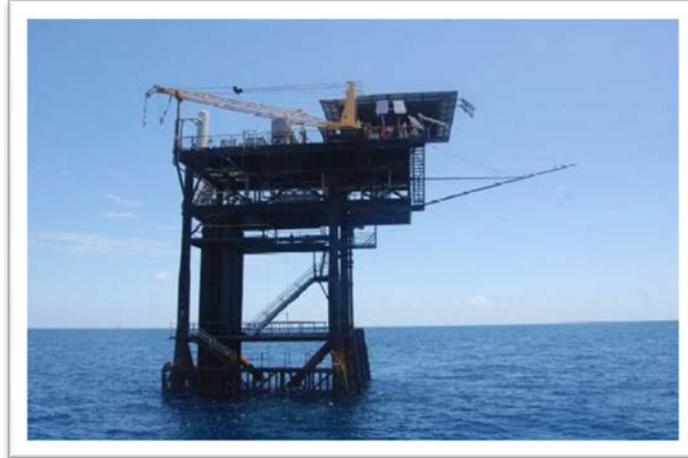
**Figure 17 – Arrival at Chevron Platform #2 (4 pile platform in 130 feet of water)**

The vessel arrived at the second fixed oil and gas platform to be inspected by the Lockheed Martin AUV system on July 18, 2012. This platform was a Chevron-owned asset, Platform #2, which was a four-pile platform located in approximately 130 feet of water. This platform is shown in Figure 17.

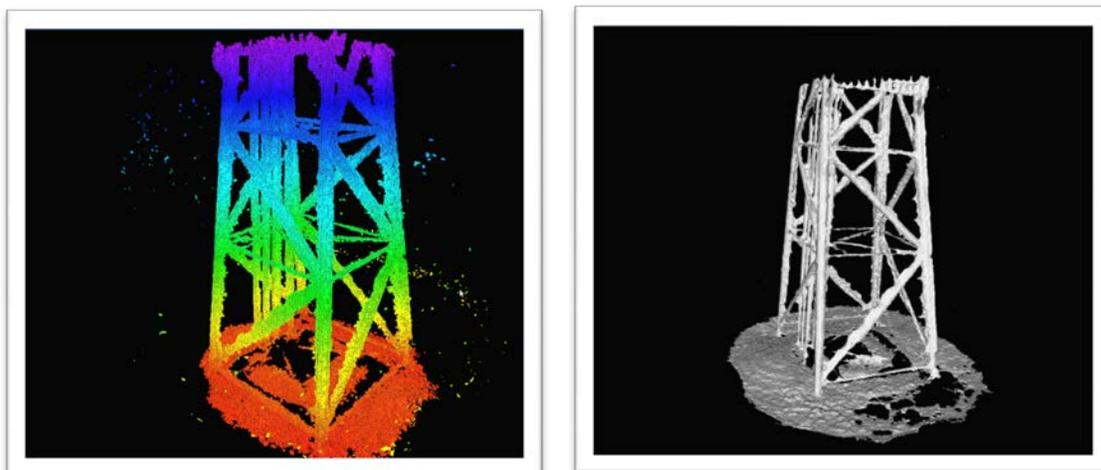
**Figure 18 - Results from Model Building Mission for Platform #2 at 15m Offset**

Similar to what was done on Platform #1, the first autonomous mission conducted on this platform was a model-building mission, since no previous information (drawings or 3D models) about the platform existed. During this mission, the Marlin™ AUV autonomously circled the platform on a pre-planned mission at various standoff distances from the platform that ranged from as far away as 50 meters to as close as 10 meters and at various depth slices in order to scan the entire height of the platform. The collected imagery of the platform using the Marlin™ onboard CodaOctopus Echoscope 3D sonar was then used to construct a high resolution 3D model of the platform via post-processing of the data using a Lockheed Martin developed analysis tool. The resulting high-resolution 3D models from these scans are shown in Figure 18. The left side of the figure shows a high resolution version of the constructed model that is colored by depth. The right side of the figure shows the same model after additional post processing, which adds a skin to the structural members. Both models were created from sonar imagery data that was collected during the 15-meter offset runs.

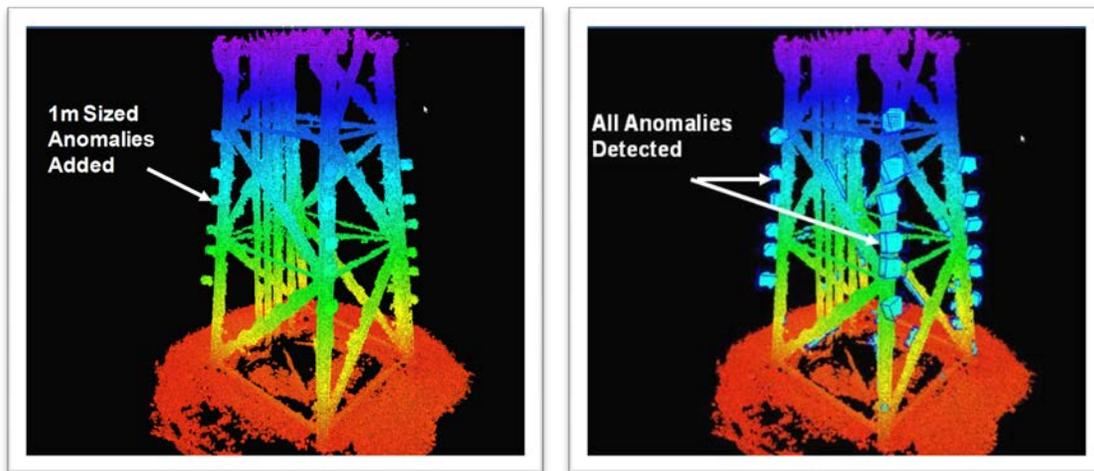
**Figure 19 - Results from Platform Inspection Mission for Platform #2 with Anomalies Detected**

The first platform inspection run on Platform #2 was conducted on July 19, 2012. For this run, anomalies were incorporated into the 3D model that was constructed from the previous model building missions. Several different sized and shaped anomalies were incorporated into the model, ranging in size from one cubic foot to one cubic meter in open and encumbered space around the platform. This model became the base (*a-priori*) model that was used as the basis for comparison during additional inspection runs. The altered model was loaded into the Marlin™ AUV, and an inspection mission was conducted at 15-meter offset from the platform at increasing depth slices until the entire platform was imaged. The scanned imagery was compared to the base model and changes were automatically detected, highlighted, and localized in real-time. Figure 19 shows the results of the autonomous inspection run for the one cubic meter anomalies. The left side of the figure shows the base (*a-priori*) model that was altered with anomalies, and the right side of the figure shows the imagery from the subsequent inspection mission overlaid on the base model with the changes highlighted with blue boxes indicating a negative change (something that should be there that is not). Note that all of the changes were detected as negative changes because the anomalies were added to the base (*a-priori*) model. Since the actual platform that was imaged by the Marlin™ AUV did not contain these anomalies, they were detected as something that was not part of the structure that should have been.

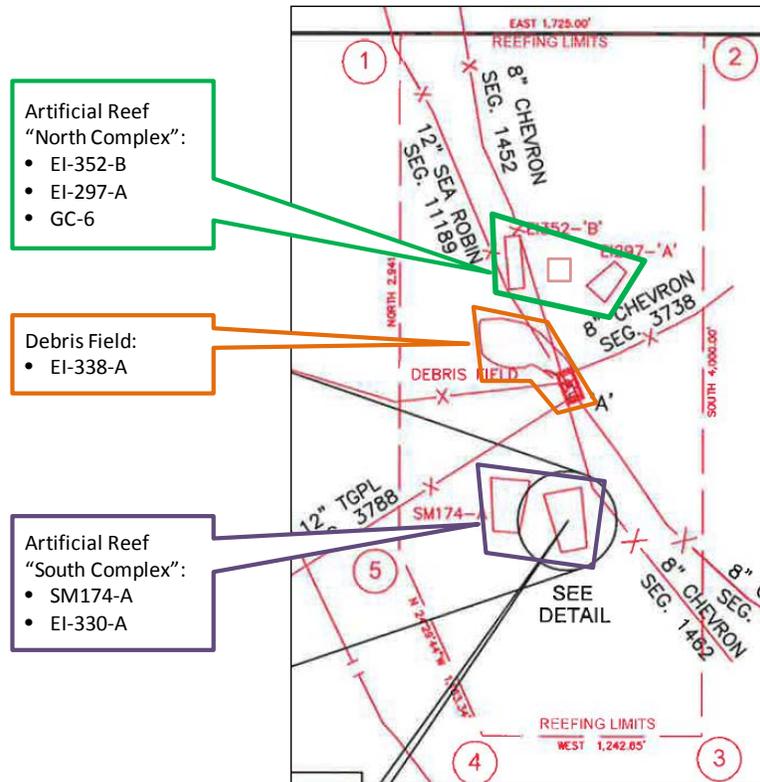
**Figure 20 - Artificial Reef Complex EI-338**

During this eight-day portion, the Marlin™ AUV inspection system was used to conduct surveys of various reefed platforms that were scattered along the bottom of the ocean floor within reef complex EI-338. This site contained three platforms on the north side of the reef complex, two platforms on the south side, and a debris field in between. Since this operation was not part of the original scope of the demonstration, the Lockheed Martin team had to generate new operational concepts for conducting a survey in a field with no surface-piercing structures that could be used as a reference. The new operational concept was developed rather quickly by the Lockheed Martin operations team and tested in the onboard simulation environment within the operations van before actual execution of the mission. This quick adaptation to a changing environment demonstrated the flexibility of the Marlin™ AUV inspection system. The artificial reef complex that was utilized for this survey is in approximately 265 feet of water and is shown in Figure 20.

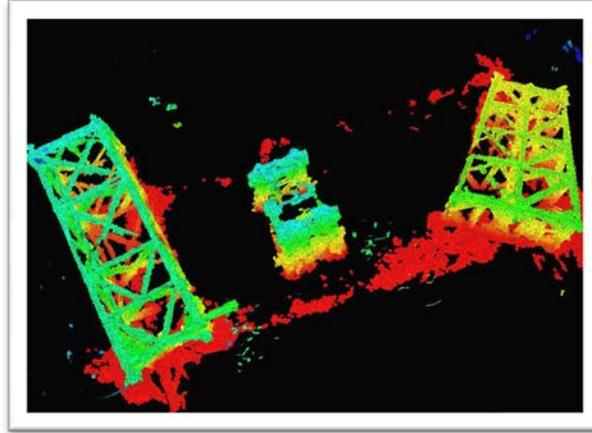
**Figure 21 – Low Resolution Spiral Survey Mission Results of Artificial Reef Complex EI-338 (North Complex)**

Since no previous information was known about the reefed structures, other than what is shown in Figure 20, the first autonomous mission that was conducted was a model building mission over the reef’s north complex containing platforms EI-352-B, EI-297-A and GC-6. During this mission, the Marlin™ AUV autonomously circled high above the reefed platforms in a spiral pattern at a depth (first 100 feet) that was considered safe and free of structures. Once the mission was completed, the vehicle was surfaced and the imagery was offloaded via Marlin™ Radio Frequency (RF) link. A low-resolution model of the area was then constructed in a similar fashion as the fixed platform model building process. Once confidence was established that there was no other structure in the path of the Marlin™ AUV based on the low-resolution model of the area, the spiral surveys were conducted deeper and closer to the reefed platforms to obtain higher resolution sonar imagery and construct higher resolution 3D models. The spiral surveys continued on Days 2 and 3 over the reef’s North complex and debris field. The low-resolution 3D model that was constructed from the initial spiral survey mission over the reef’s north complex is shown in Figure 21.

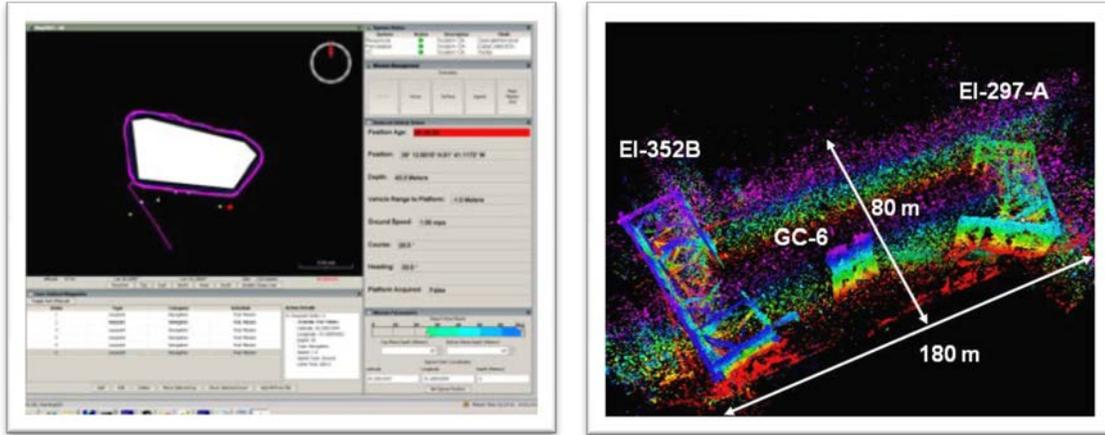
**Figure 22 – Low Resolution Results from 15M Offset Model Building Mission of Reef's North Complex**

The low-resolution results from the 15-meter offset model building mission over the reef’s north complex are shown in Figure 22. The left side of the figure shows the topside operator user interface window with the mission plan and results displayed, and the right side of the figure shows the constructed 3D model with approximate field size dimensions that were generated from the collected imagery data within one to two hours after offloading it from the vehicle.

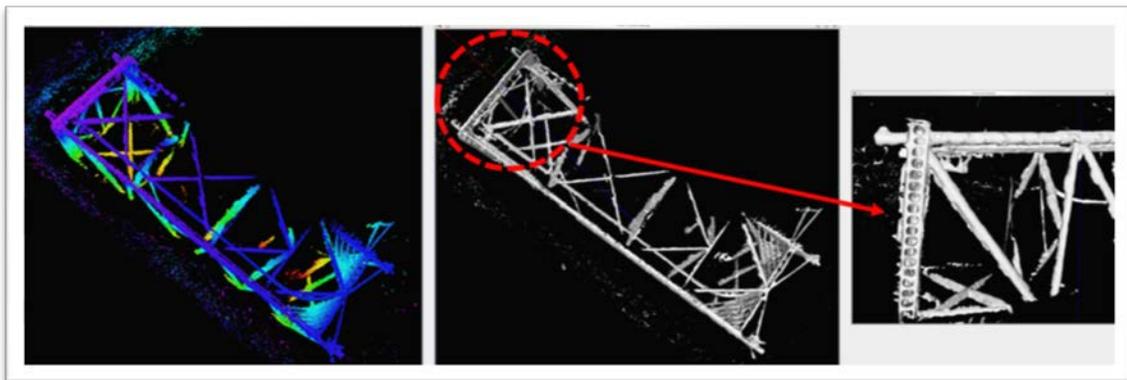
**Figure 23 – High Resolution 3D Model of North Complex, Platform EI-352-B**

Additional post-processing of this data using Lockheed Martin-developed model-building tool resulted in a higher resolution constructed model of platform EI-352-B as shown in Figure 23.

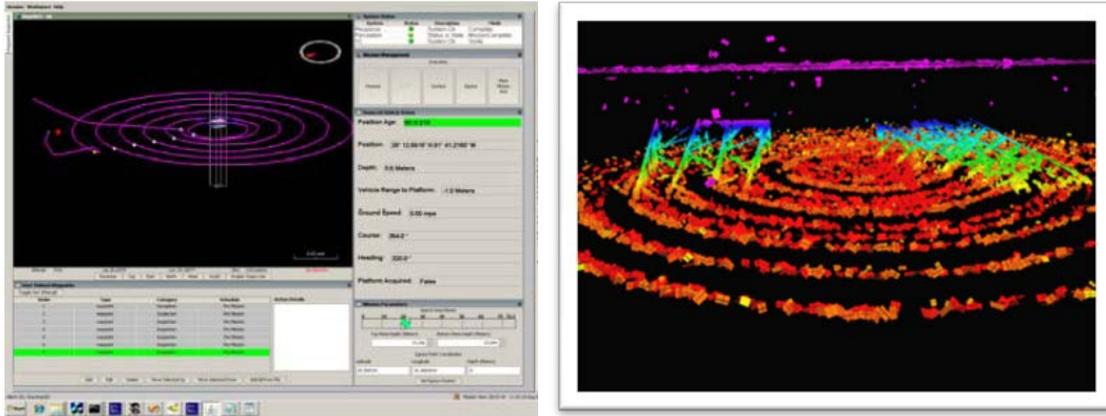
**Figure 24 – Spiral Survey Mission Results Over Reef Complex EI-338 (South Complex)**

An initial spiral survey over the reef's south complex (SM174-A, EI-330A) was accomplished next in a similar fashion as the north complex. The constructed model from the initial spiral survey mission over the reef's south complex is shown in figure 24. The left side of the figure shows the topside operator user interface window with the spiral mission results displayed, and the right side of the figure shows the constructed 3D model that was generated within one to two hours after offloading the data from the vehicle.

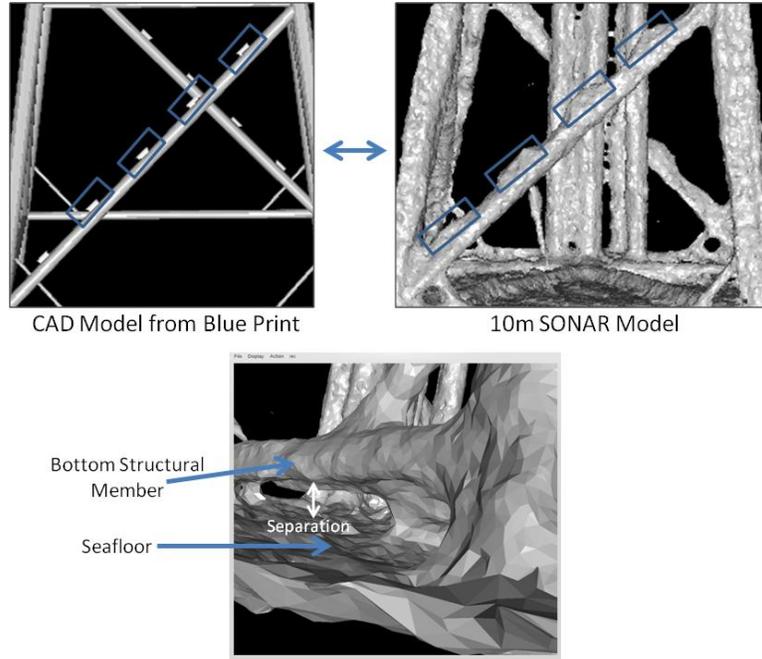
**Figure 26 – Feature Comparison (CAD Model vs. Constructed Model from Trials)**

A comparison of the features depicted on the 3D constructed model with the CAD model was completed resulting in very good correlation including clearly visible anodes and separation between the seafloor and bottom structural member. These results are shown in Figure 26.

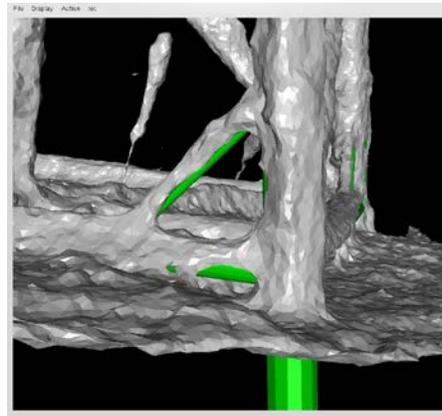
**Figure 27 – Comparison of CAD Model with 3D Constructed Model for Chevron Platform #2**

Another analysis that was completed was to overlay the 3D model that was constructed over the CAD model. Once again, there was a very close correlation between the two as shown in figure 27. The CAD model is shown in green, and the gray represents the 3D model that was constructed from the model-building runs at a 10-meter offset.
